Manhole Inspection Summary

Manhole # S29K__078MH

Location Address: **1009 Barre St**

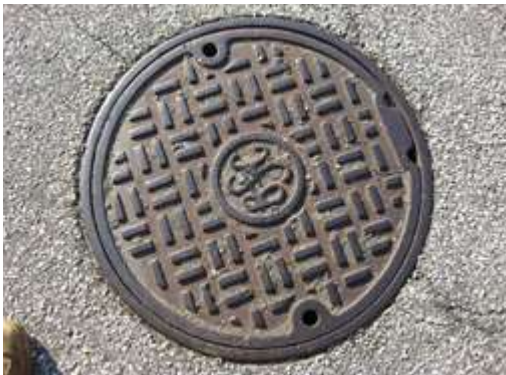
Miscellaneous

cover pic

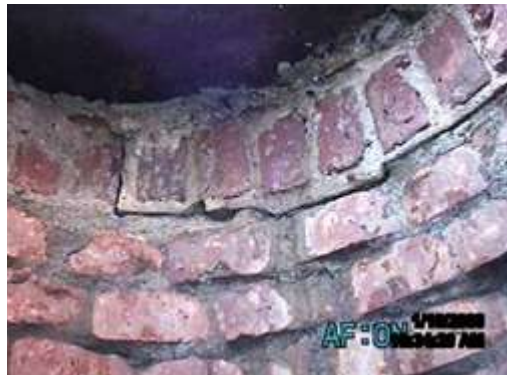
Defect 4

Condition: ☐ Sound ☒ **Cracked** ☐ Root Intrusion ☐ Loose Brick ☐ Deteriorated

cracked mortar at chimney

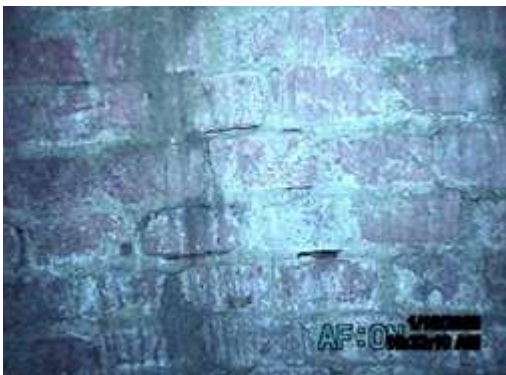
Defect 3

Infiltration: ☐ None ☐ Joint ☐ Cracks ☒ **Mortar** ☐ Roots ☐ Wall

missing mortar at barrel

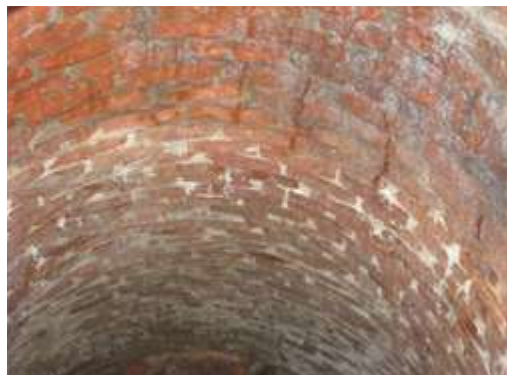
Defect 1

Infiltration: ☐ None ☒ **Joint** ☐ Cracks ☐ Mortar ☐ Roots ☒ **Wall**

infiltration from chimney joint/wall

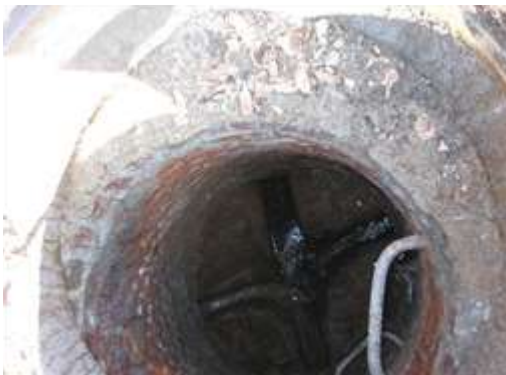
Defect 5

Offset: **5** (in.)

Count: **4** Missing: **0** ☒ **Corroded**

frame offset 5", steps corroded

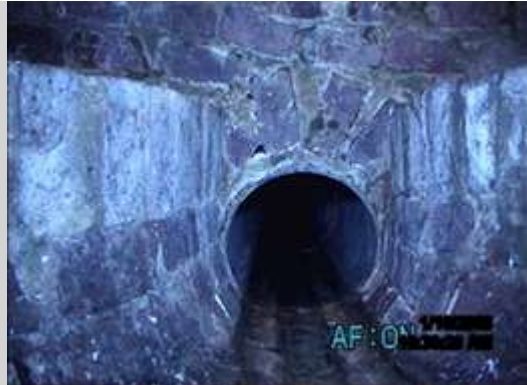
12 O'Clock Outflow

8 in. Circular Gravity Sewer
Pipe Out @ 12 O'Clock

Pipe Height: **8.4** (in.) Rod and Bar (Angled)
Pipe Material: **Clay** ☐ Pipe Lined
Invert Depth: **9.80** (ft.) Flow Characteristics: **Slow**
Deposits: ☒ None ☐ Mud ☐ Sludge ☐ Debris ☐ Grease
Silt Depth: **0** (in.) Deposits Extent:
Infiltration: **None** Pipe Seal Cond: **Sound**

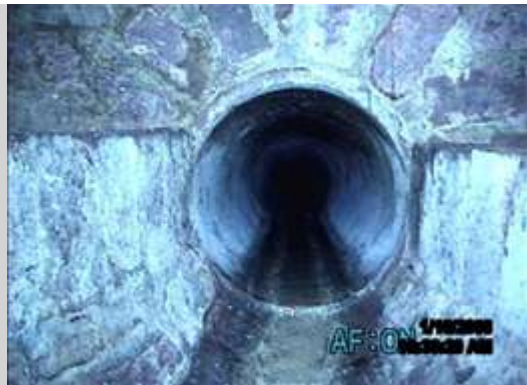
3 O'Clock Inflow

8 in. Circular Gravity Sewer
Pipe In @ 3 O'Clock

Pipe Height: **8.4** (in.) Rod and Bar (Angled)
Pipe Material: **Clay** ☐ Pipe Lined
Invert Depth: **9.61** (ft.) Flow Characteristics: **Slow**
Deposits: ☒ None ☐ Mud ☐ Sludge ☐ Debris ☐ Grease
Silt Depth: **0** (in.) Deposits Extent:
Infiltration: **None** Pipe Seal Cond: **Sound**

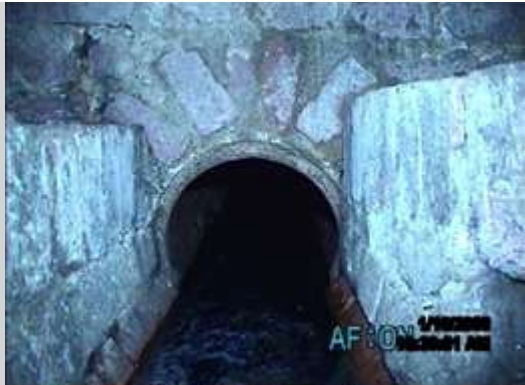
6 O'Clock Inflow

Pipe Height: **8.4** (in.) Rod and Bar (Angled)

Infiltration: **None** Pipe Seal Cond: **Sound**

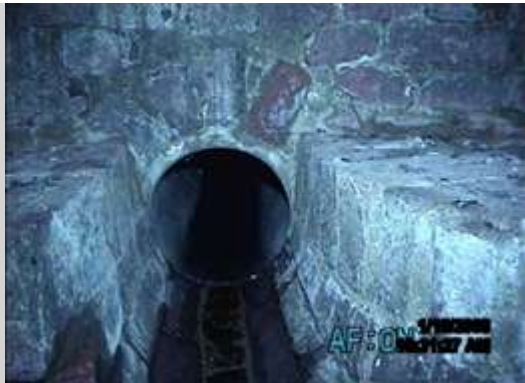
9 O'Clock Inflow

Pipe Height: **8.4** (in.) Rod and Bar (Angled)

Infiltration: **None** Pipe Seal Cond: **Sound**

Connects To: **Dead End**
